**NASA
Technical
Paper
3190**

External Stress-Corrosion Cracking of a 1.22-m-Diameter Type 316 Stainless Steel Air Valve

Thomas J. Moore,
Jack Telesman,
Allan S. Moore,
Dereck F. Johnson,
and David E. Kuivinen

Lewis Research Center
National Aeronautics and Space Administration
Cleveland, Ohio, May 22, 1992

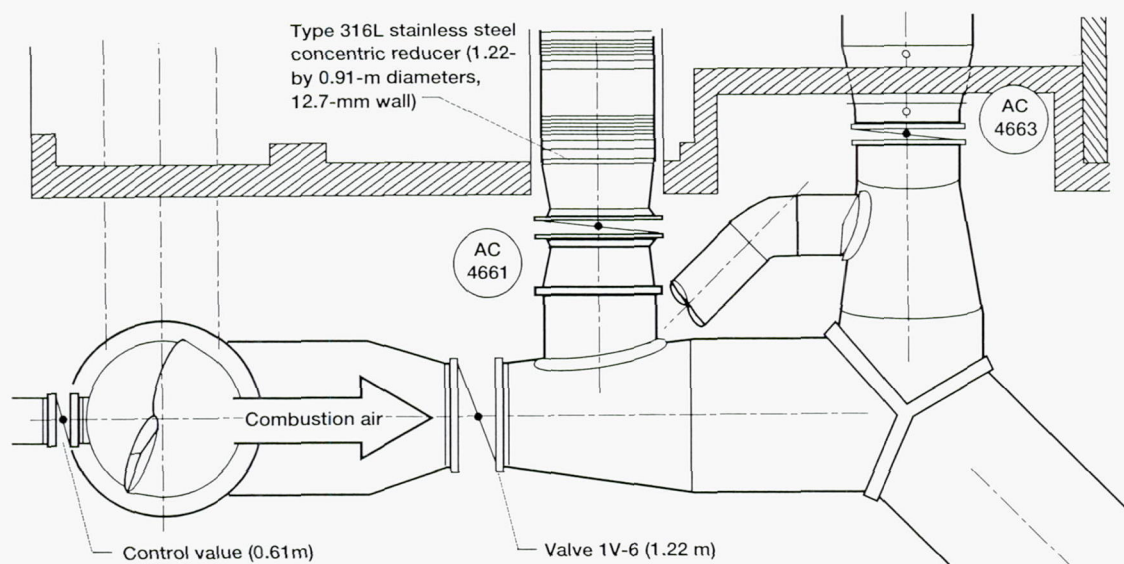
Figure 1.—A portion of the plan drawing of the outdoor air supply system. Cracking occurred at valve 1V-6.

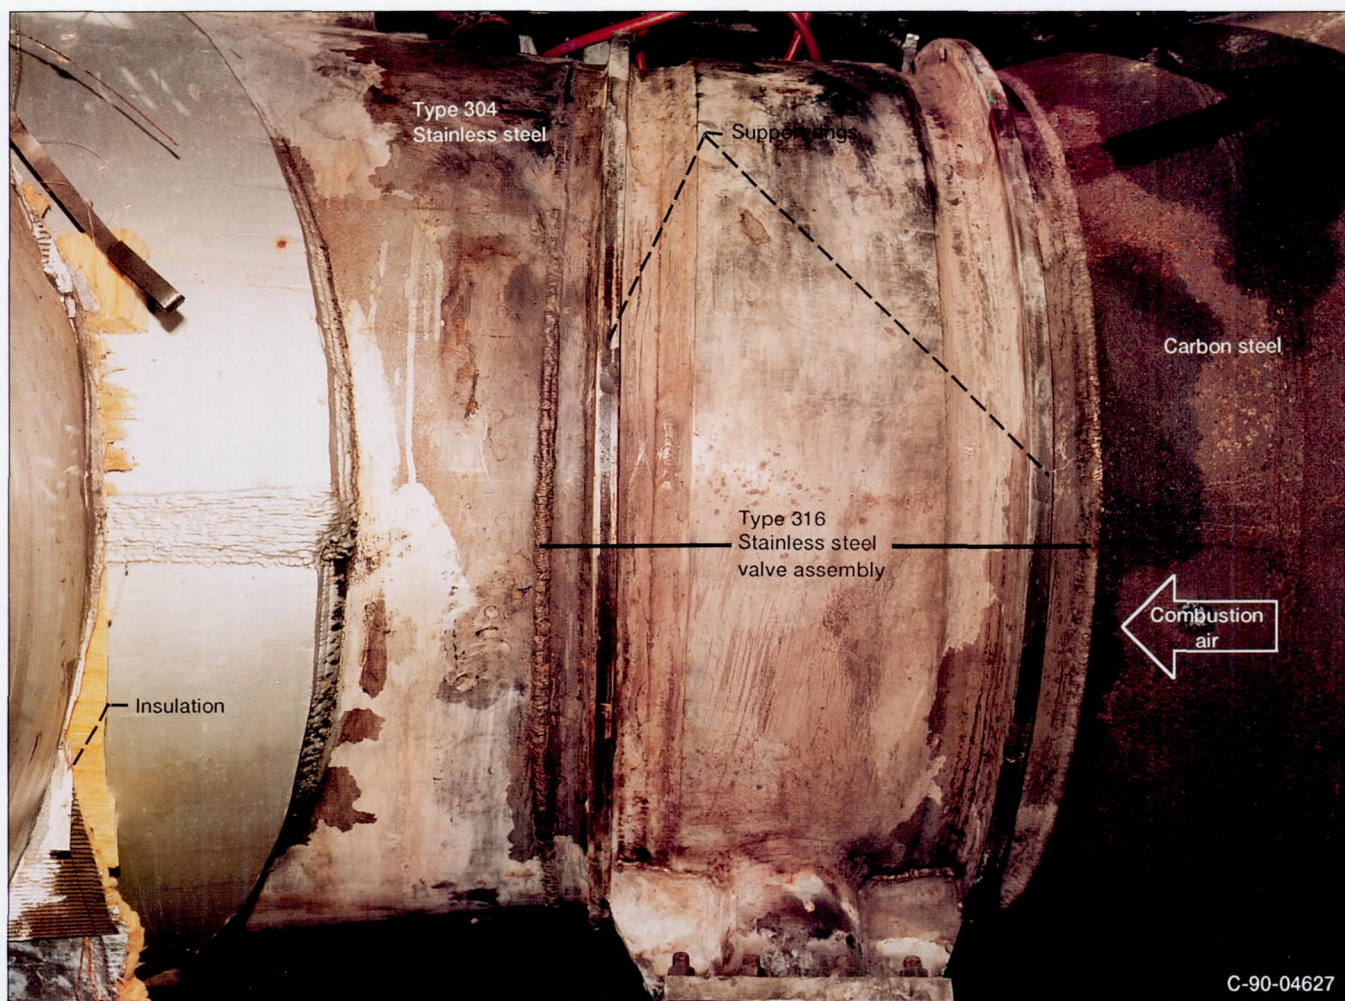
Figure 3.—Valve 1V-6 (1.22-m diam) with insulation removed showing dual support rings welded to the valve skirt.

The 1.22-m-diameter by 15-mm-wall Type 316 stainless steel valve 1V-6 is shown in figure 3 with the fiberglass insulation removed. The carbon steel air inlet pipe and the Type 304 stainless steel outlet pipe are also shown. Support rings (25.4 mm wide by 51 mm high) were welded to the skirt in T-joints on both the upstream and downstream sides of the butterfly valve. The metallographic failure investigation was concentrated primarily at the downstream side of the valve where dye penetrant inspection first revealed two through-the-wall cracks in the valve skirt. Later in the investigation, other cracks, including a through-the-wall crack, were discovered at the upstream side of the valve. Although these latter cracks were characterized, the photomicrographs are not presented herein.

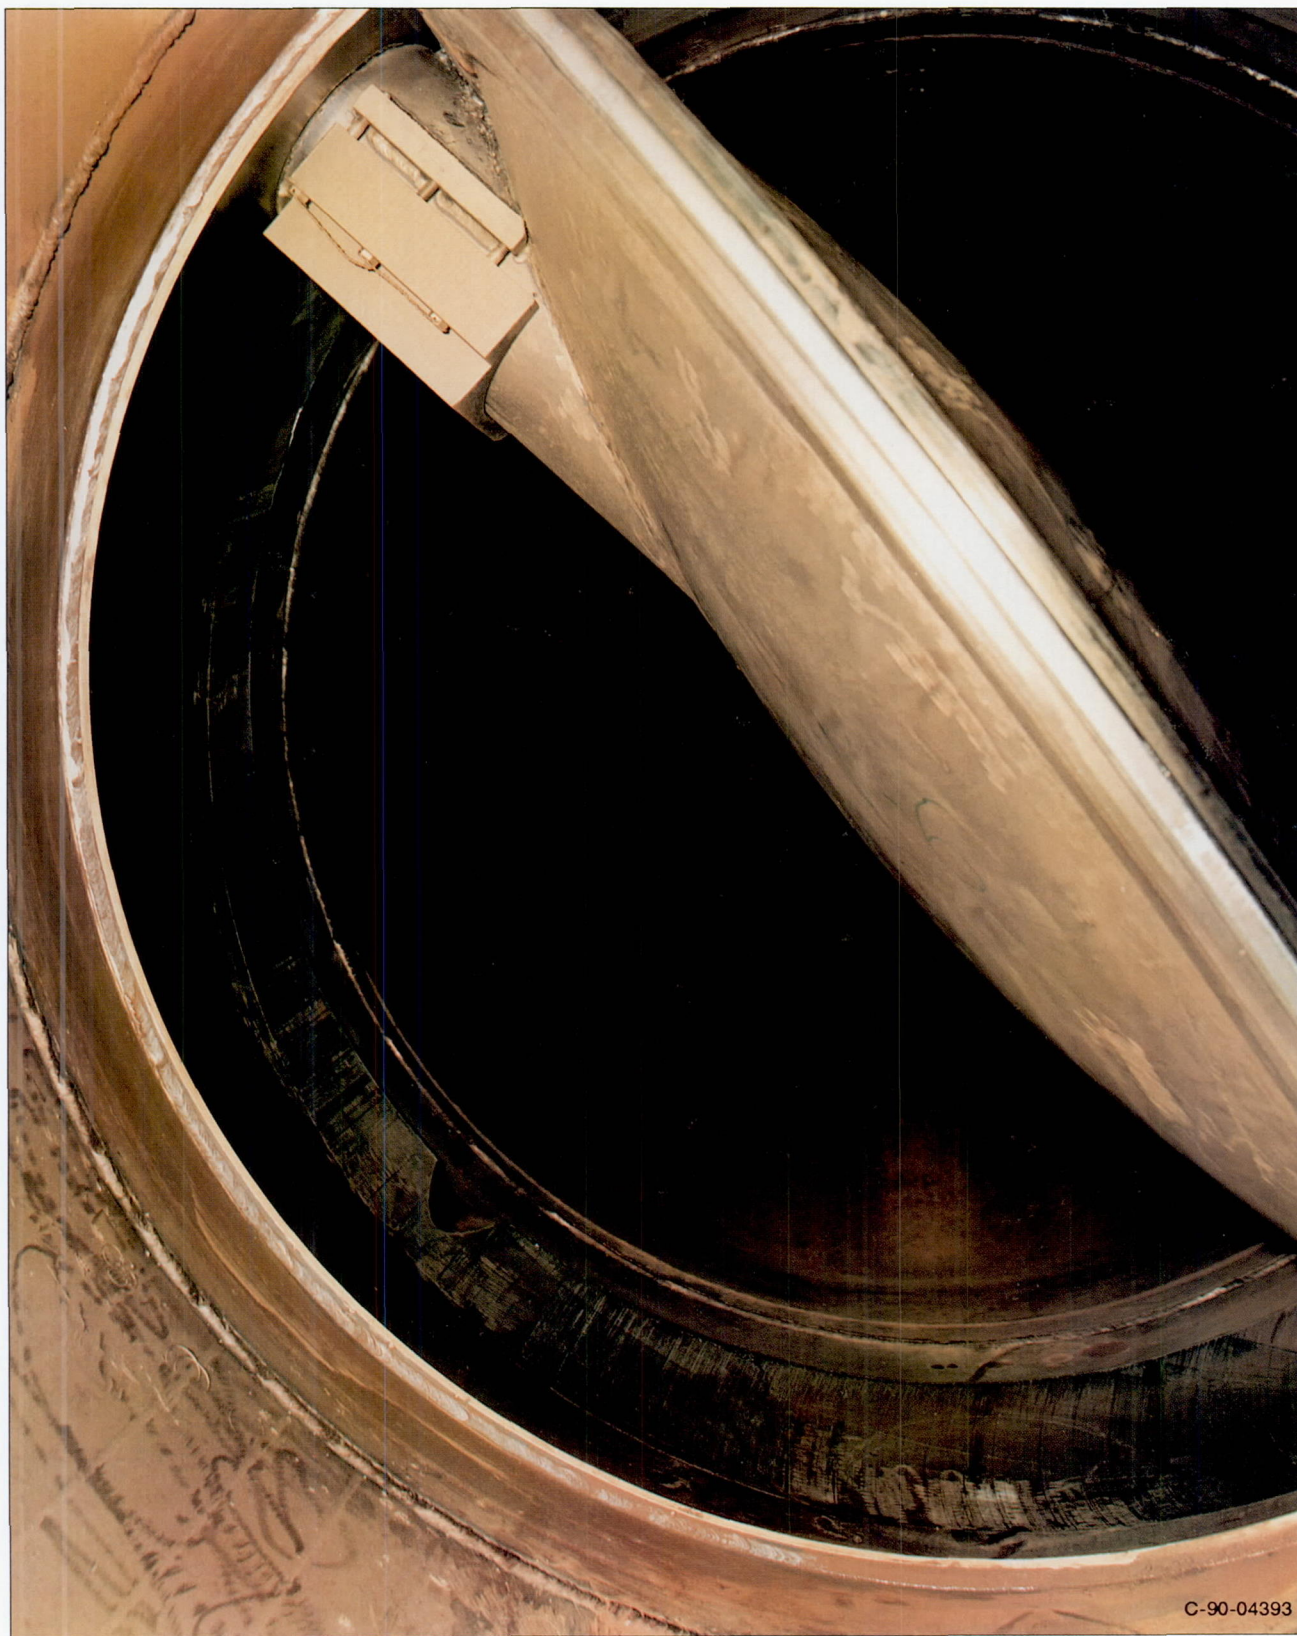
An internal view of the valve in the open position (looking upstream) is shown in figure 4. An identical view in the closed position is shown in figure 5. Through-the-wall cracking was present in the weld HAZ for about half the

Figure 4.—Internal view (looking upstream) of valve 1V-6 in the open position.

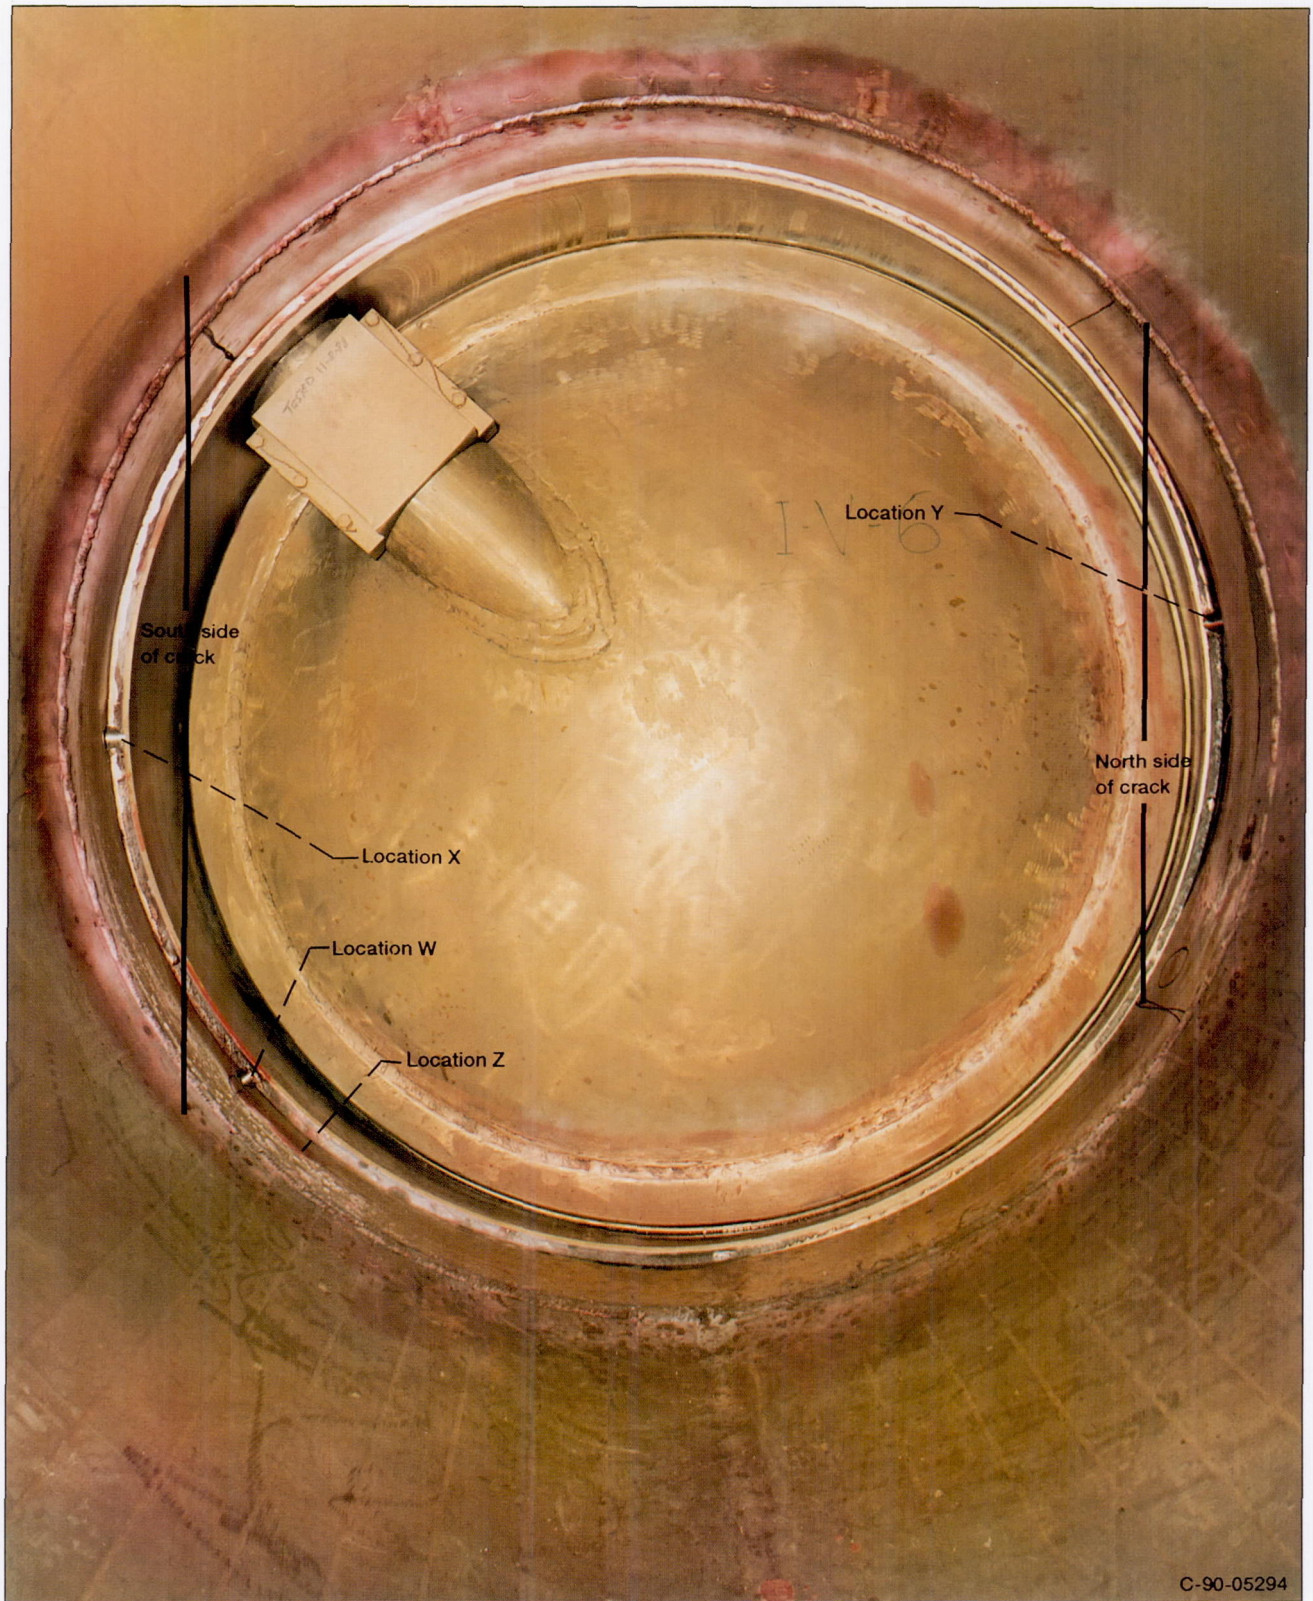
C-90-05294

circumference of the butt joint on the south and north sides. Figure 5 also shows the locations from which 21-mm-diameter metallographic plug samples W, X, and Y were taken from the butt joint and the region from which sample Z was taken from the T-joint. Figures 6 and 7 are external views showing the plug holes, which were centered at the butt joint cracks. The plugs included weld metal, HAZ, and unaffected base metal. Figure 6 also shows that the area of sample Z (which was cut out later) included a portion of the support ring. The internal view in figure 8 shows the plug holes of samples X and W and a portion of the through-the-wall toe crack from the external ring-to-skirt T-joint. This toe crack, which was evident along the inner circumference, was parallel to the circumferential butt joint crack. These cracks were only about 25 mm apart. Sample Z (shown in fig. 9), which contains the toe crack, was obtained by manual plasma arc cutting. The downstream support ring was included with a 10- by 26-cm portion of the skirt. Cross sections of sample Z were taken transverse to the support ring for both macro- and micro-examination.

Figure 5.—Internal view (looking upstream) of valve 1V-6 in the closed position. The locations from which samples W, X, Y, and Z were taken are indicated.

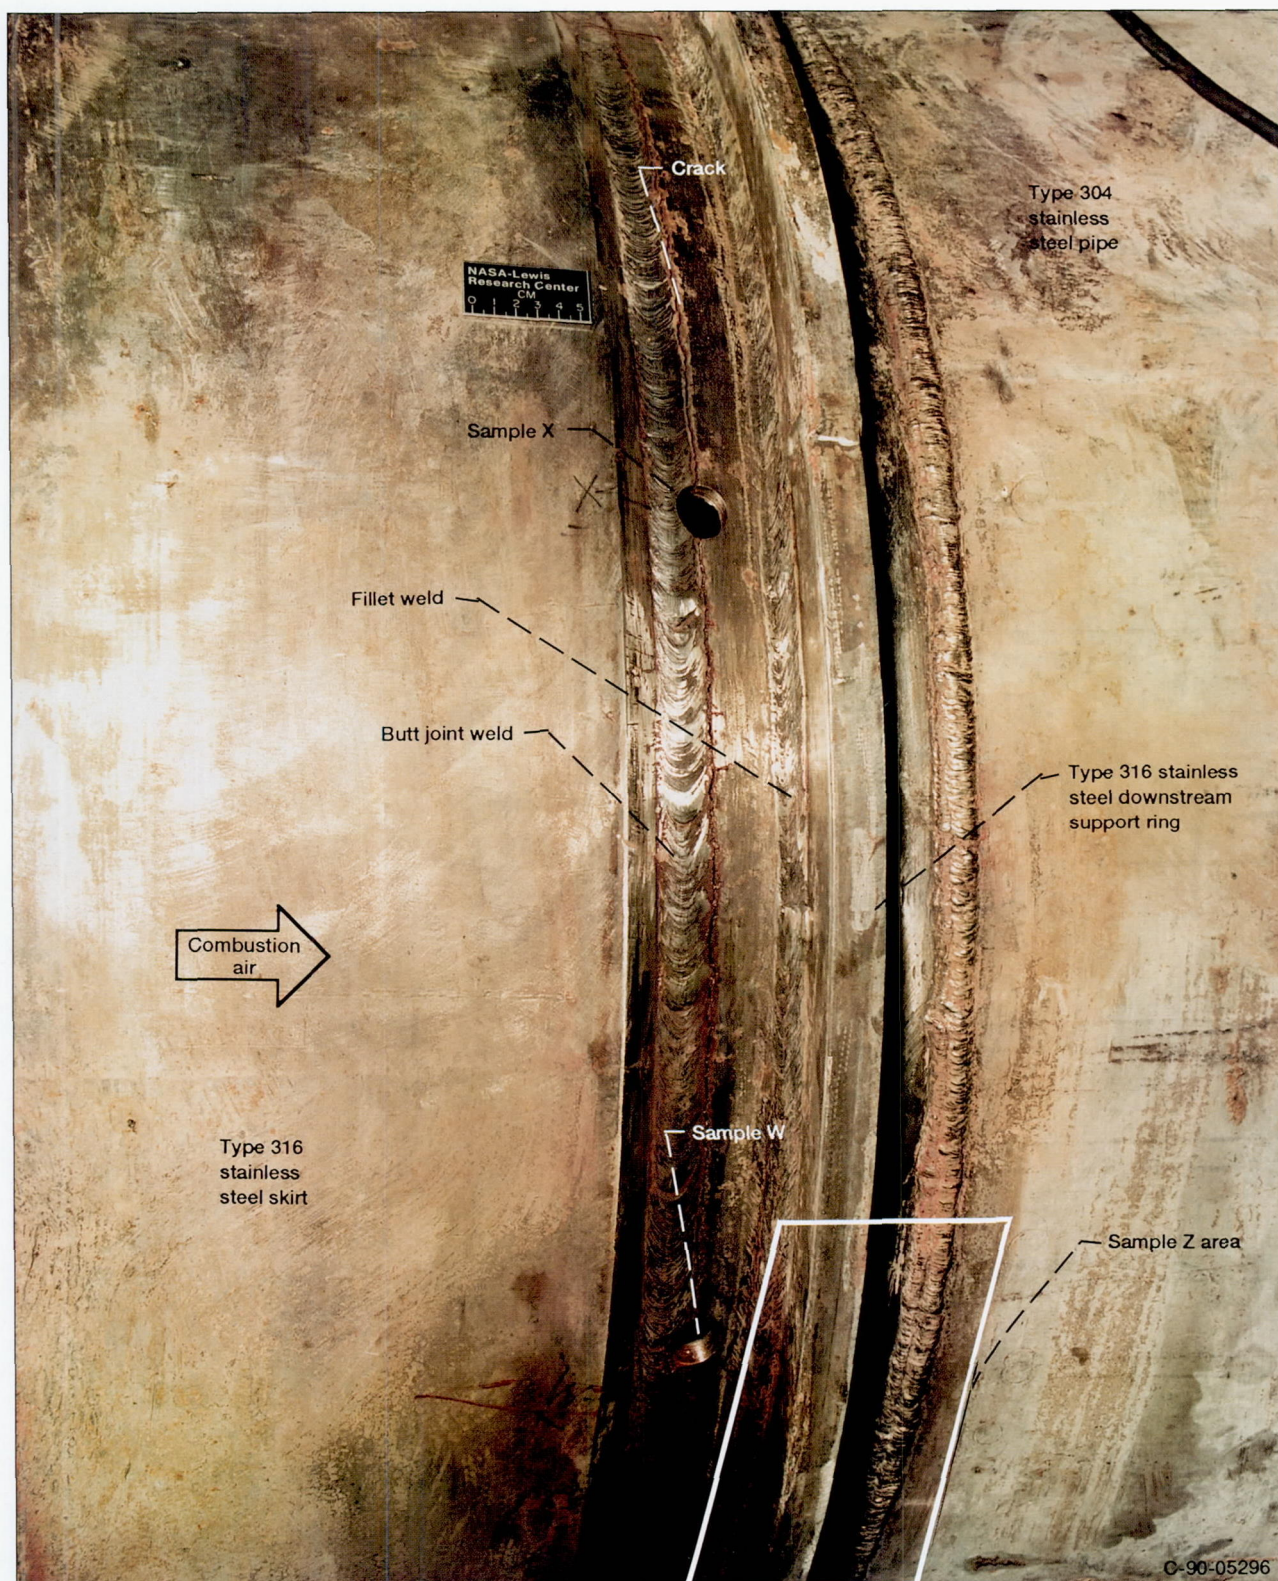
Figure 6.—External view from the south at the downstream side of valve 1V-6 showing plug holes for samples W and X and the area from which sample Z was taken.

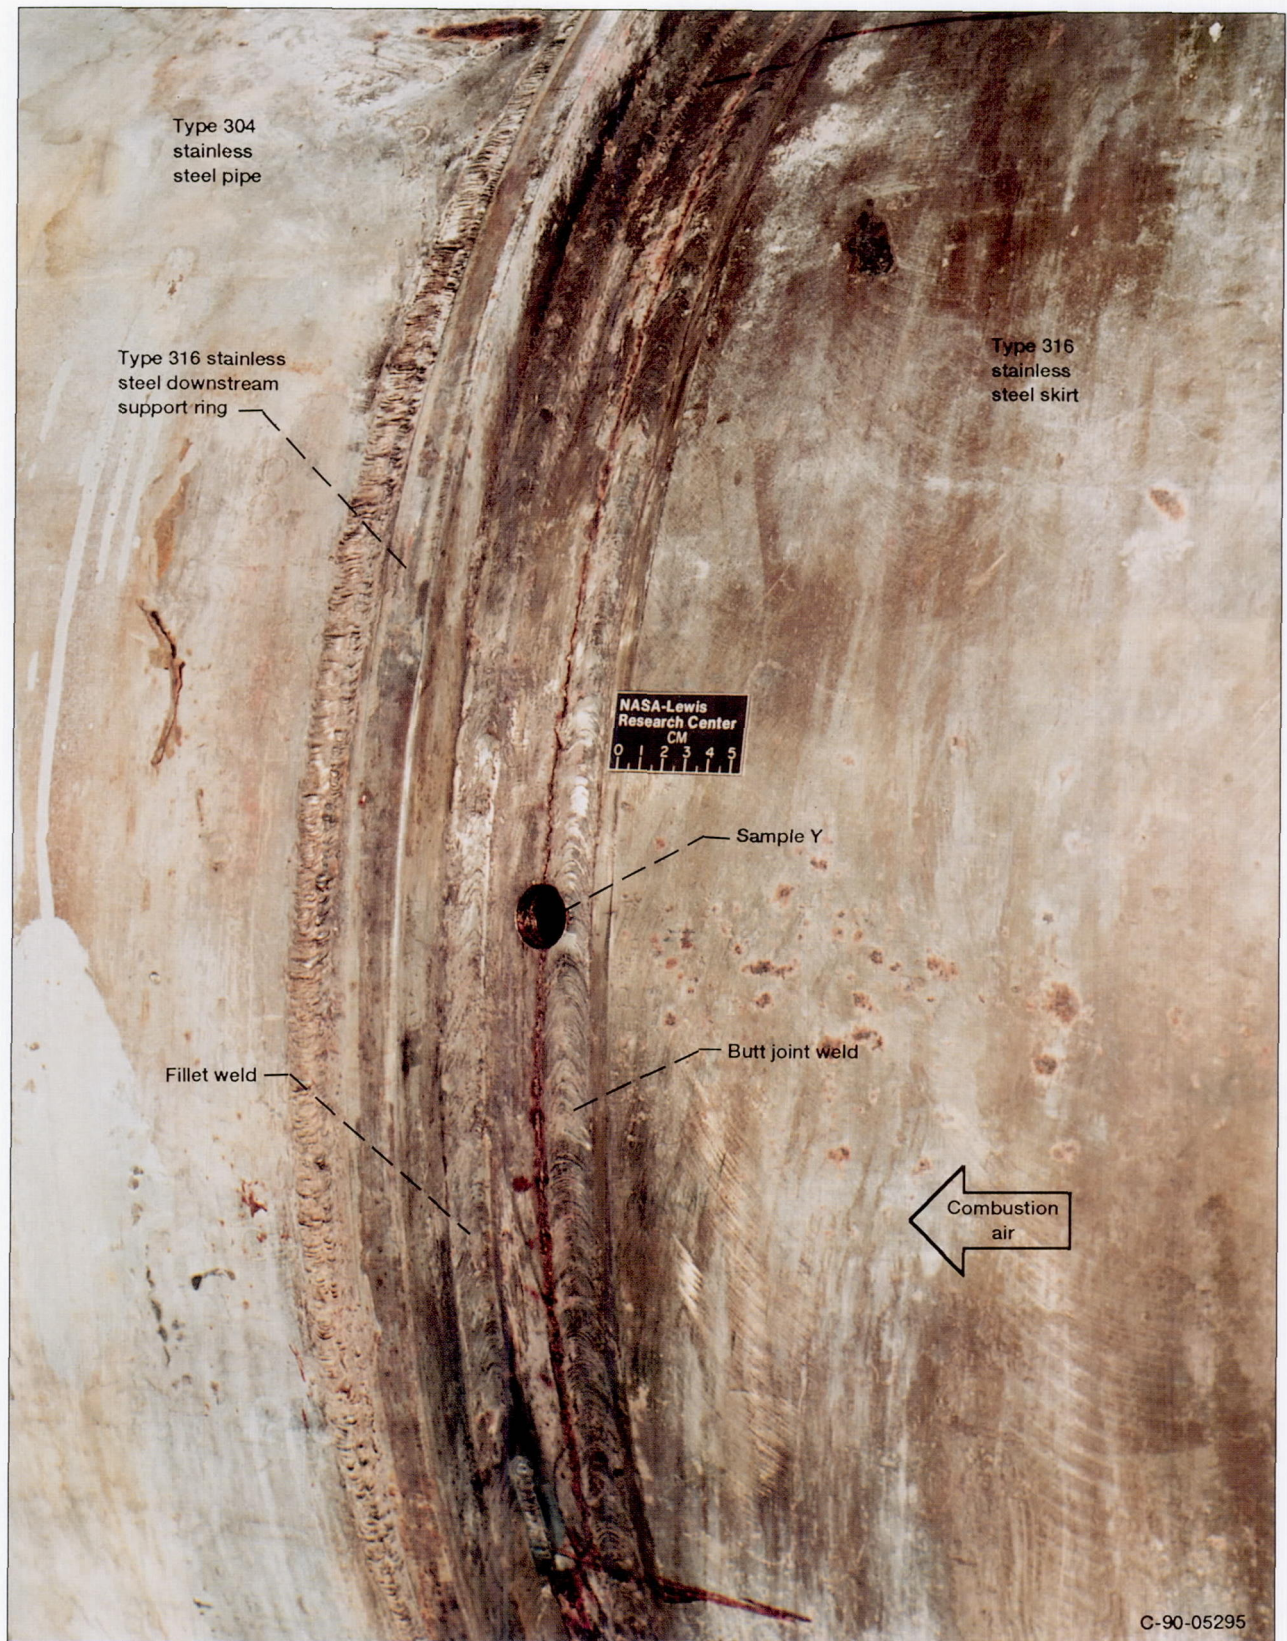
Figure 7.—External view from the north of valve 1V-6 at the downstream side showing plug hole for sample Y.

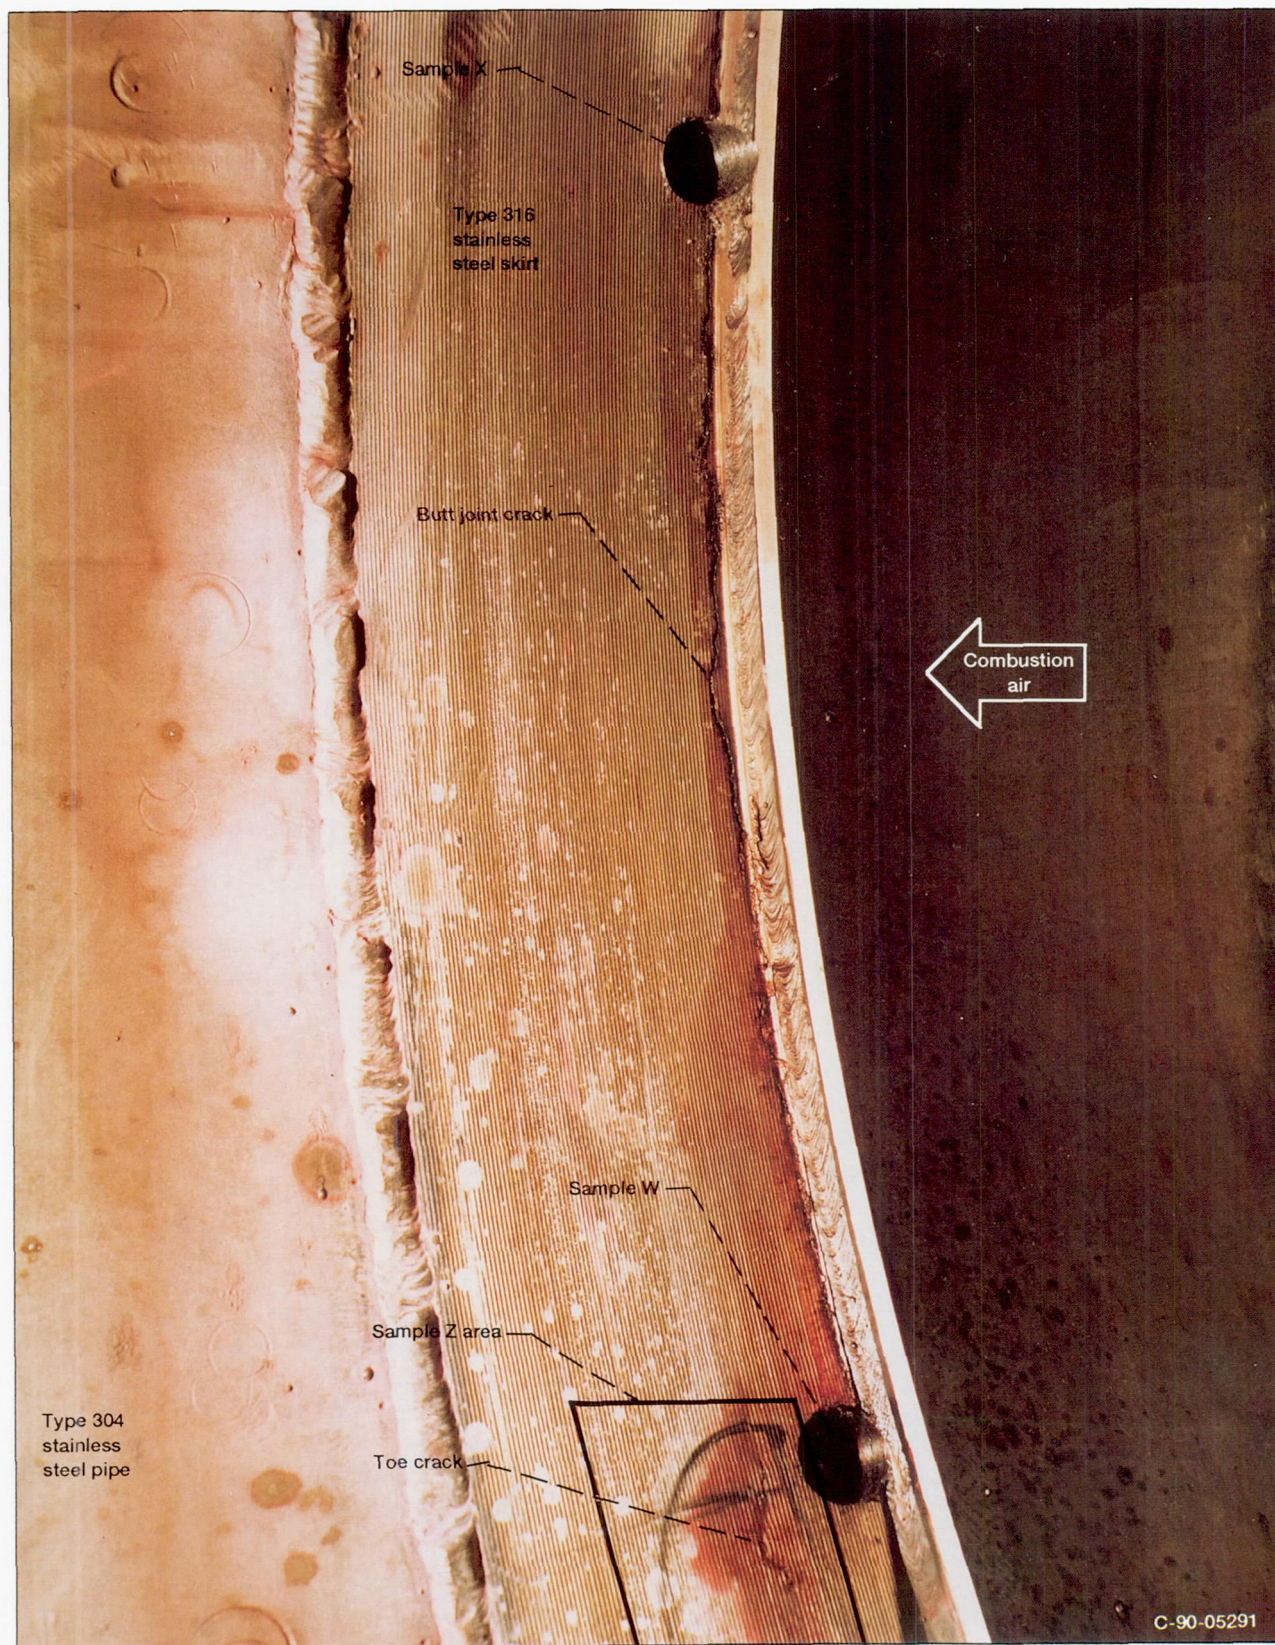
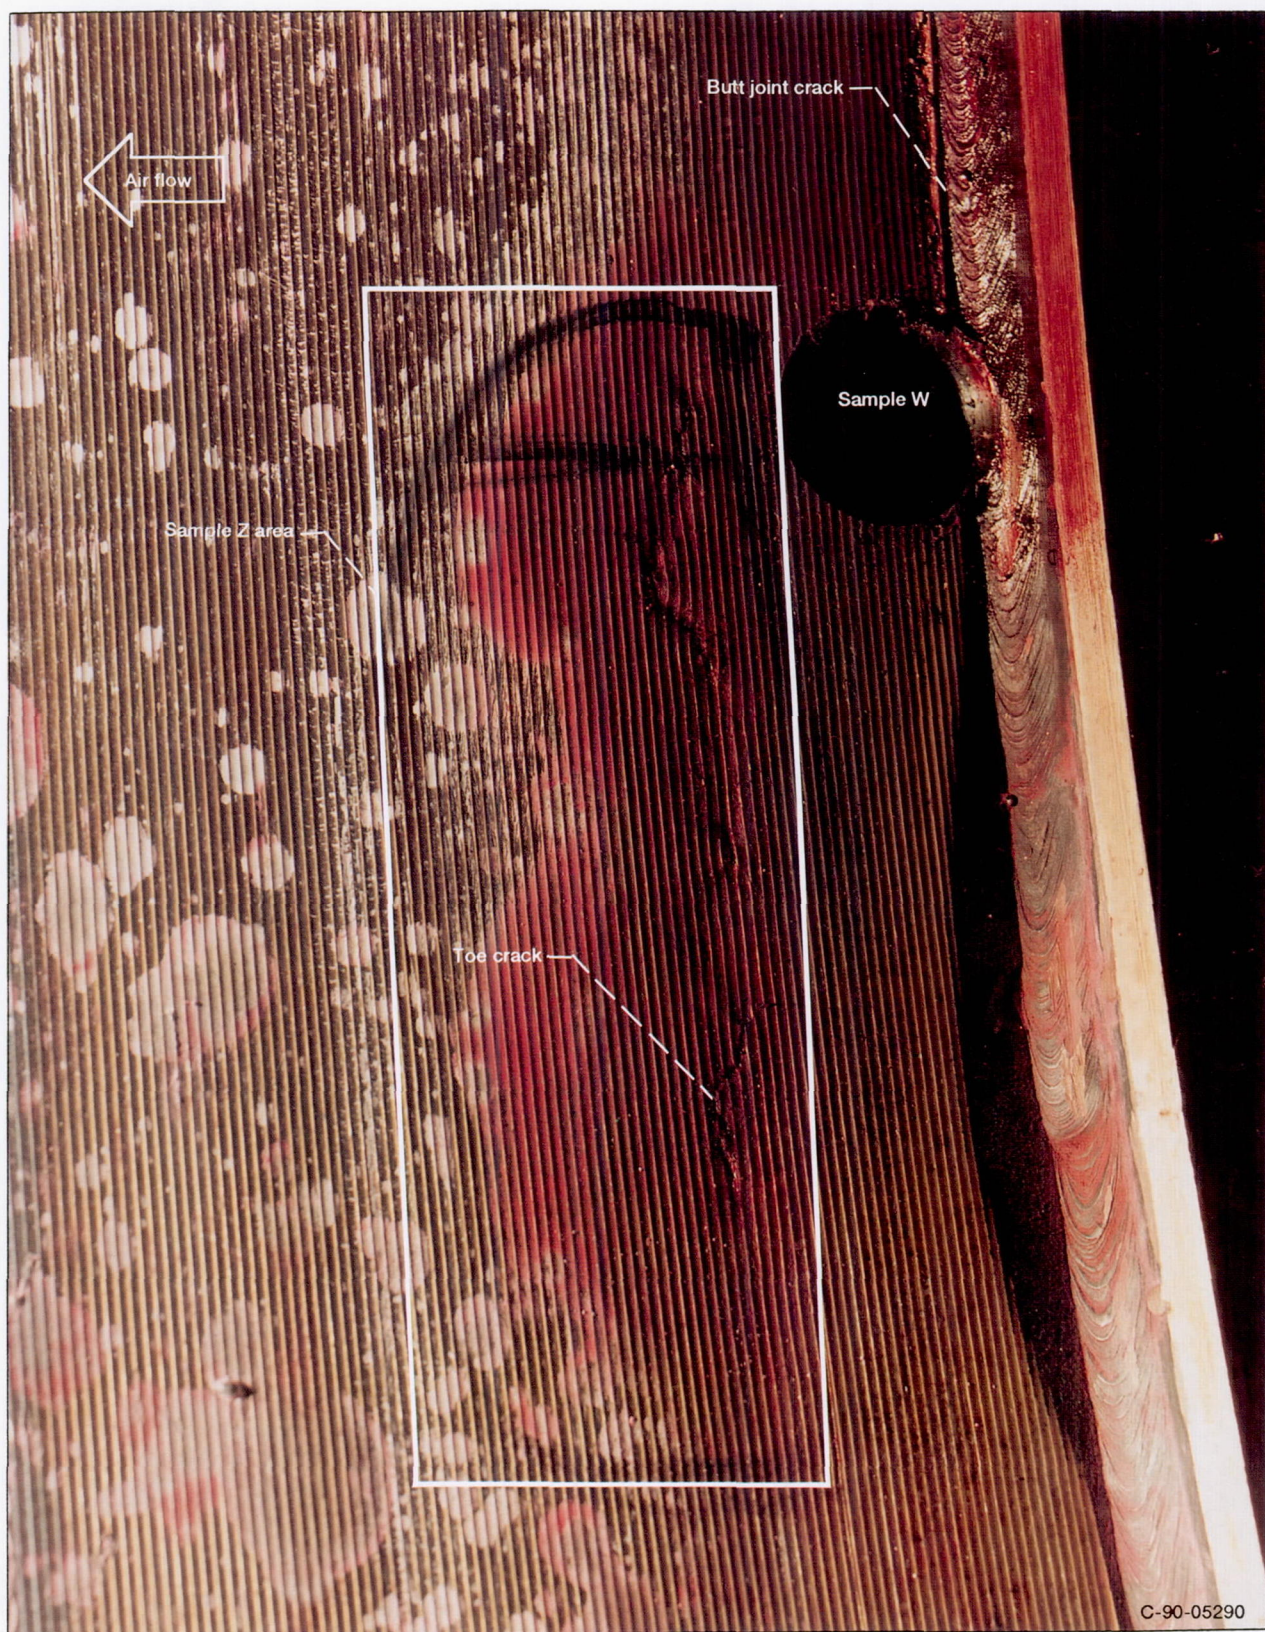
Figure 8.—Internal view at the downstream side of valve 1V-6.

(a) View of the plug holes of samples W and X and a portion of the area from which sample Z was taken.

(b) Sample W plug hole and region from which sample Z was obtained.

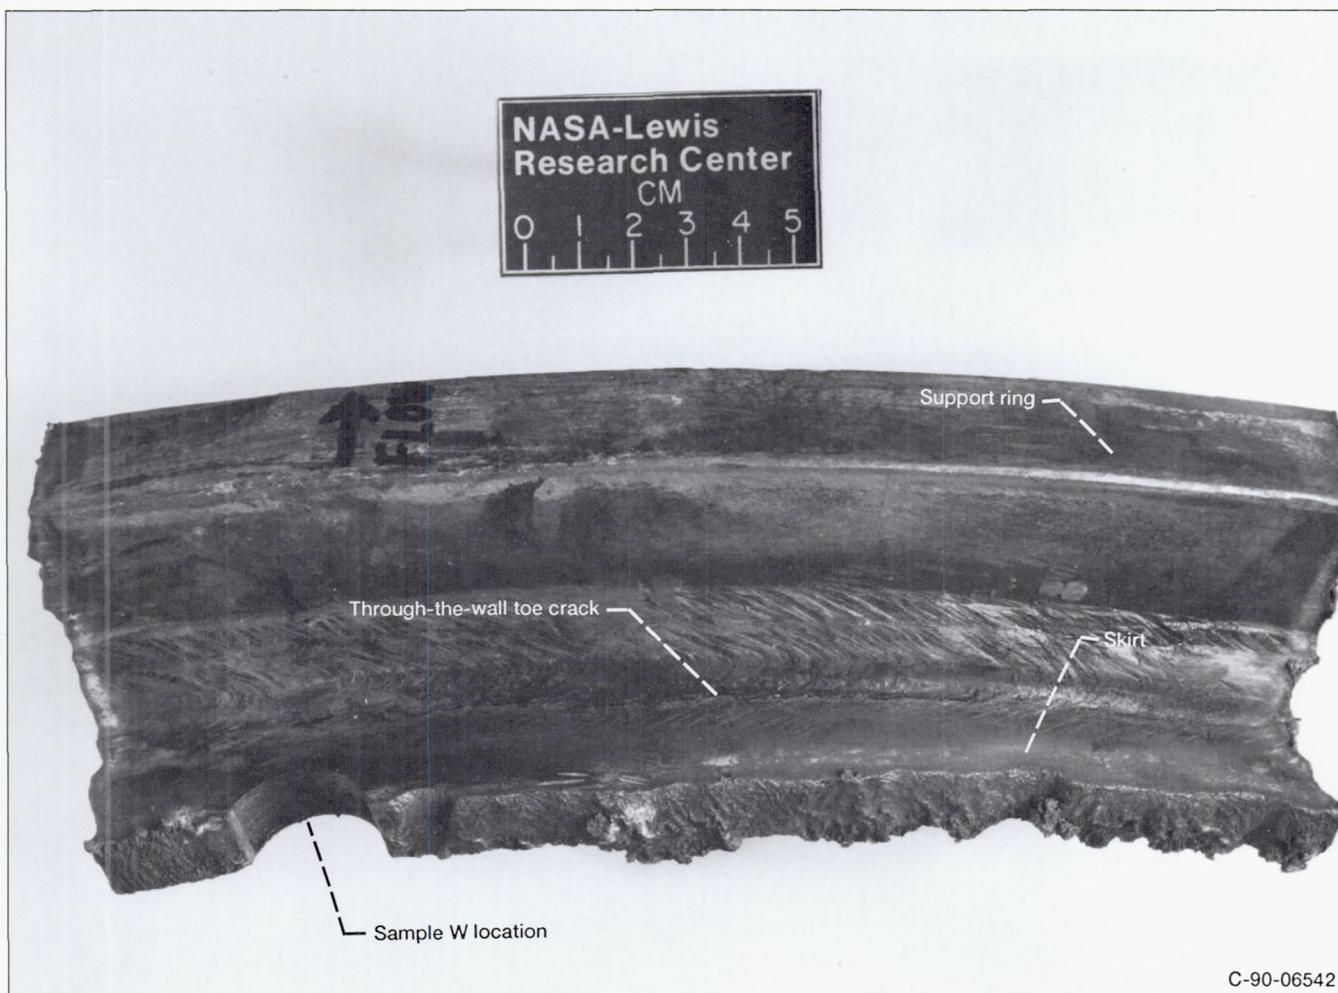
Figure 9.—Sample Z (a 10-cm by 26-cm section of the skirt), including a portion of the downstream support ring T-joint.

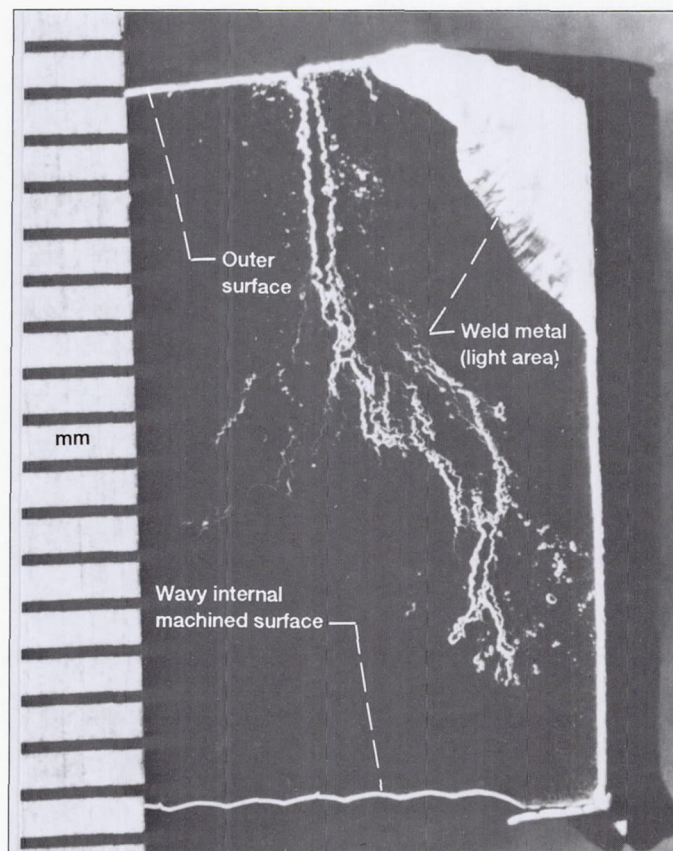
Plug specimens X and Y both separated into two pieces because at these locations the butt joint crack extended through the full thickness of the skirt. For specimen W, the crack did not penetrate completely through the skirt wall. It is

Figure 10.—Macrograph of stress-corrosion cracking in the heat-affected zone of a circumferential butt joint in Type 316 stainless steel (specimen W).

evident from the cracking pattern shown in figure 10 that the crack started at the outer surface of the skirt. Below the surface, it became branched. Figures 11(a) and (b) illustrate the intergranular nature of the cracking.

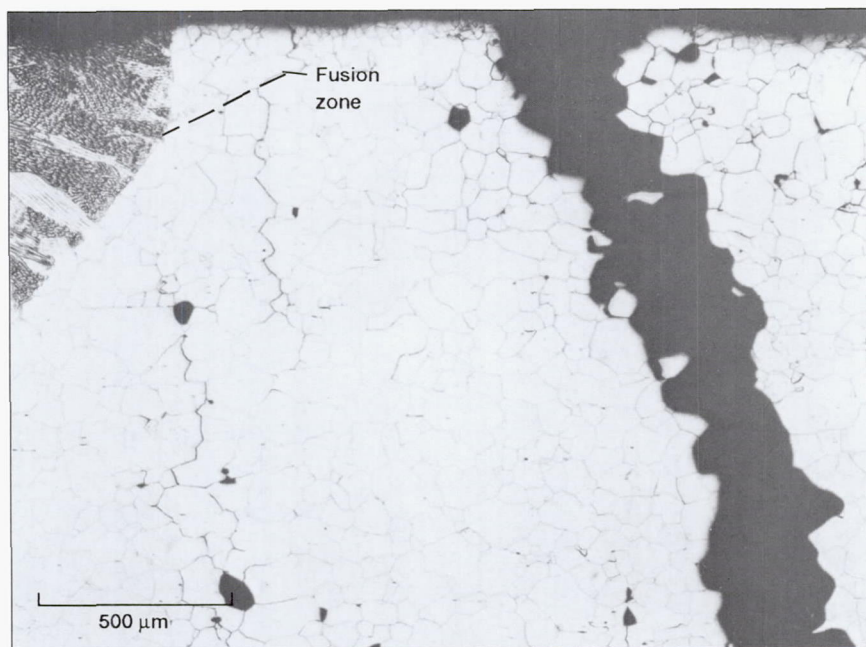
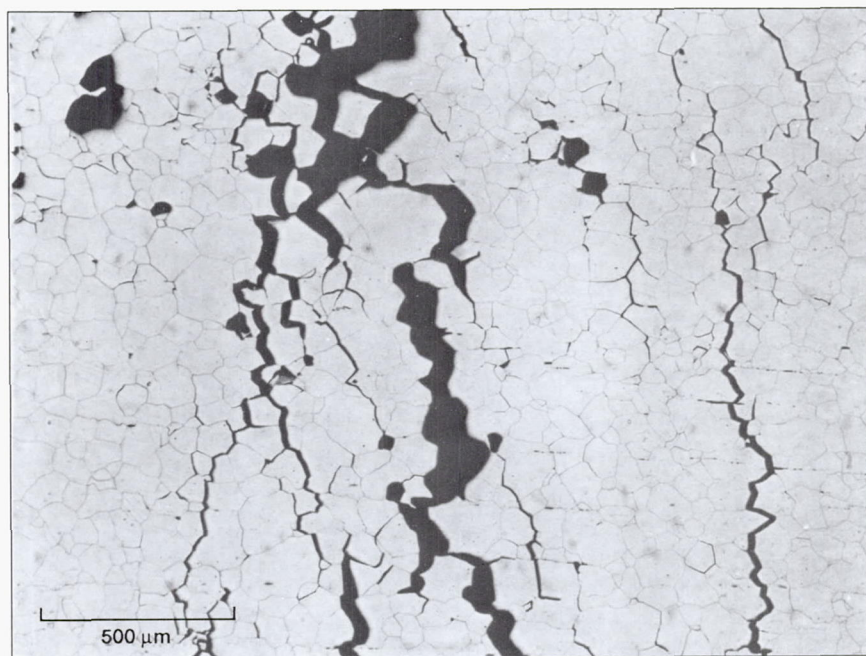
Figure 11.—Intergranular nature of the stress-corrosion cracking in the heat-affected-zone of the circumferential butt joint (specimen W).

(a) Intergranular, heat-affected-zone crack at outside surface.

(b) Intergranular, base metal cracks at midthickness of the skirt. The cracks are oriented roughly parallel to the main fracture path.

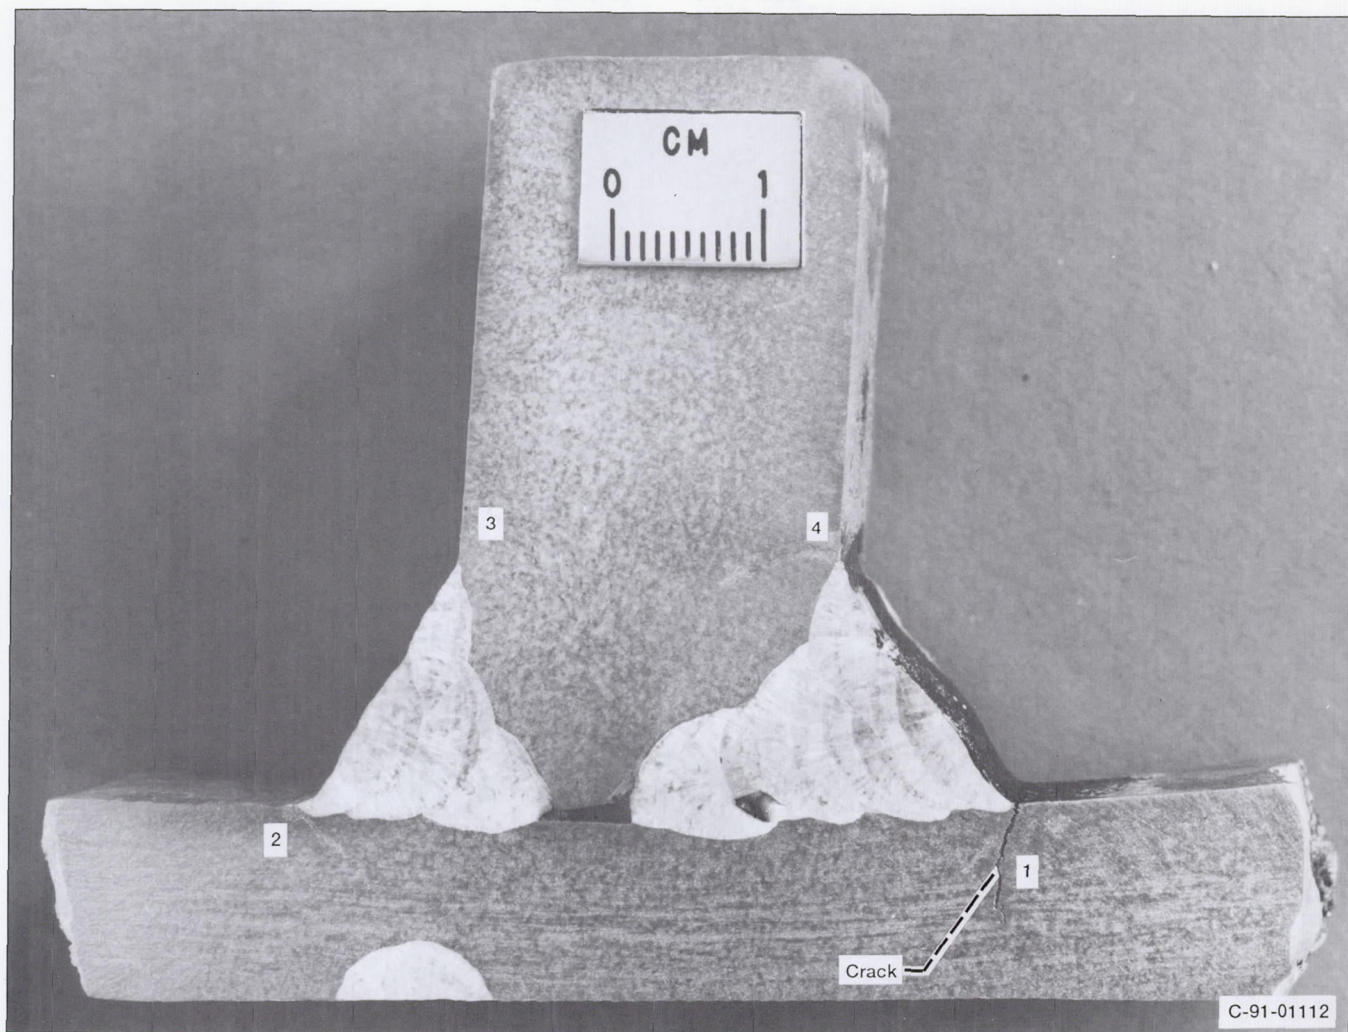
The cross section of sample Z from the valve skirt (fig. 12) shows a toe crack which extended more than half-way through the wall (location 1). Other cross sections of

Figure 12.—A cross section of sample Z T-joint showing a stress-corrosion toe crack in the Type 316 stainless steel valve skirt. Intergranular toe cracks (not evident in this photograph) are also present at locations 2, 3, and 4.

sample Z revealed that this crack had penetrated completely through the skirt for a distance of 18 cm along the circumference. Like the butt joint crack, it was narrow at the outer surface and branched as it proceeded towards the interior. The failure was intergranular, similar to that shown in figure 11. Tight, intergranular toe cracks not evident in figure 12 were present at locations 2, 3, and 4. These cracks were found only after sectioning and polishing. The cracking in the skirt at location 2 in figure 12 (shown in fig. 13(a)), extends to a depth of about 7 mm. At location 4 in figure 12, the cracking has progressed into the support ring to a depth of about 8 mm (see fig. 13(b)). At location 3 in figure 12, the cracking was only about 2 mm deep (not shown). The purpose of the autogenous gas tungsten arc weld pass at location 2 in figure 12, on the inner surface of the skirt, is not known.

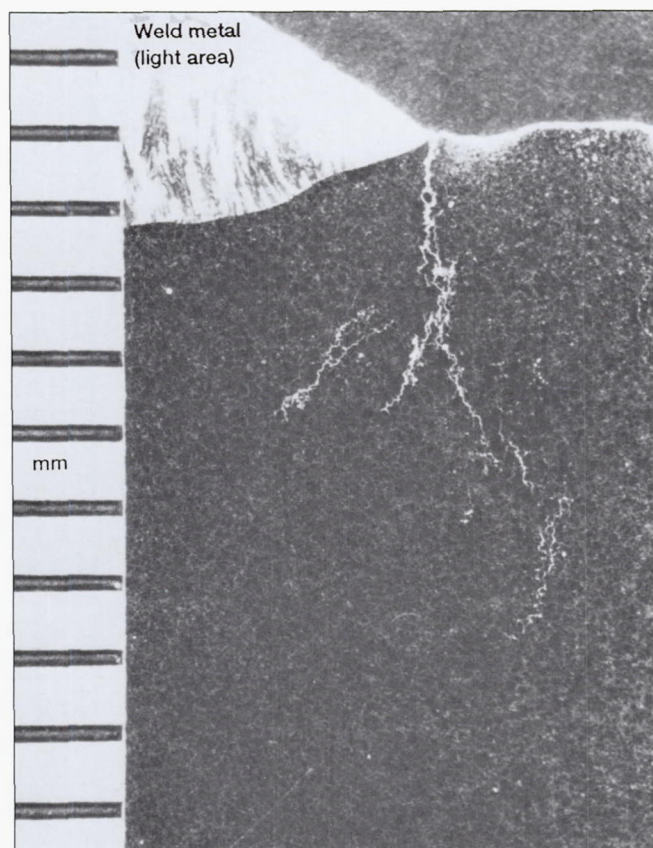
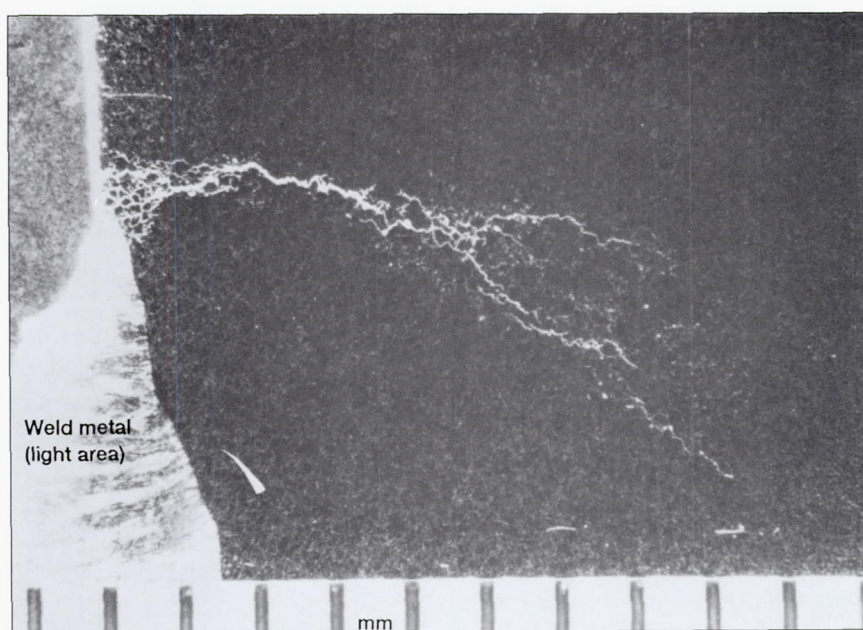
Figure 13.—Intergranular, stress-corrosion cracking at a T-joint in the Type 316 stainless steel valve.

(a) Cracking in the valve skirt at location 2 in figure 12.

(b) Cracking in the support ring at location 4 in figure 12.

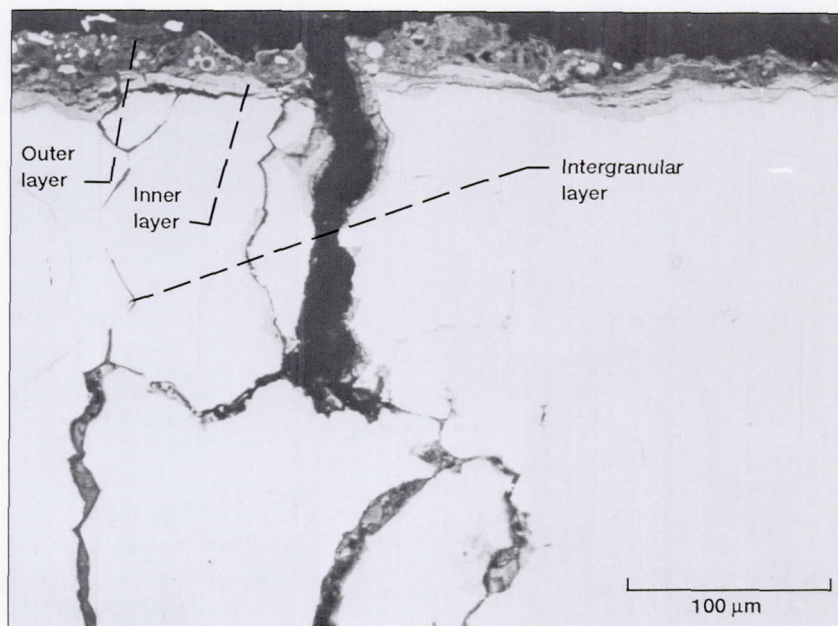
The support ring base metal toe crack at location 4 (fig. 13(b)) was the area examined. As shown in figure 14, two oxidelike layers were present at the outside surface, and a number of intergranular cracks extended from this surface into the support ring. The XEDS analysis was performed in three regions designated the outer layer, the inner layer, and the intergranular layer, respectively (fig. 14). XEDS analysis of the support ring was also conducted in a noncorroded area away from the crack.

Figure 14.—Backscatter scanning electron microscope image showing intergranular, stress-corrosion cracking and the locations that were analyzed.

A major difference in composition between the outer layer (fig. 14) and the support ring can be noted in the XEDS analysis in table I. First, the relative levels of chromium (Cr) and nickel (Ni) in the outer layer are significantly lower. Second, the outer layer appears to contain substantial quantities of chlorine (Cl), Ca, Si, and phosphorus (P). The Ca and Si indications are probably a result of plastic mounting material infiltration. But the presence of Cl, P, and possibly K are believed to result from the environment in which the valve operated. Analysis of the inner layer (shown in table I) indicates that this material is essentially Type 316 stainless steel.

Perhaps the most important information was obtained from the analysis of the intergranular layer, 150 μm below the surface of the cracked ring (fig. 14). The profile for this spectra is shown in figure 16. These data are given in table I. A comparative XEDS analysis of the base metal and the intergranular layer showed increased quantities of Cr (18.5 to 31.1 percent), Cl (0.1 to 7.9 percent), and P (0.4 to 1.3 percent). The high Cr indicates the presence of chromium carbides at the grain boundaries (i.e., a sensitized condition). In this condition, the grain boundary regions adjacent to the

carbide particles are low in Cr and are thus susceptible to corrosive attack. The presence of a relatively large quantity of Cl is significant because of the key role this element plays in stress-corrosion cracking (SCC). The indicated increases in P and K may have resulted from the operational environment. Indications of higher Ca and Si are believed to be spurious, probably resulting from the plastic mounting material.
